*(6) National Dam Inspection Report*  
**MARCEL LAKE DAM**

NDI - PA 00402,  
PA DER 52-149.

PHASE I INSPECTION REPORT,  
NATIONAL DAM INSPECTION PROGRAM

Name of Dam: Marcel Lake Dam                      ID # PA-00402  
State Located: Pennsylvania  
County Located: Pike  
Stream: Dingman's Creek  
Coordinates: Latitude 41° 15.2' Longitude 74° 57.4'  
Date of Inspection: November 22, 1978

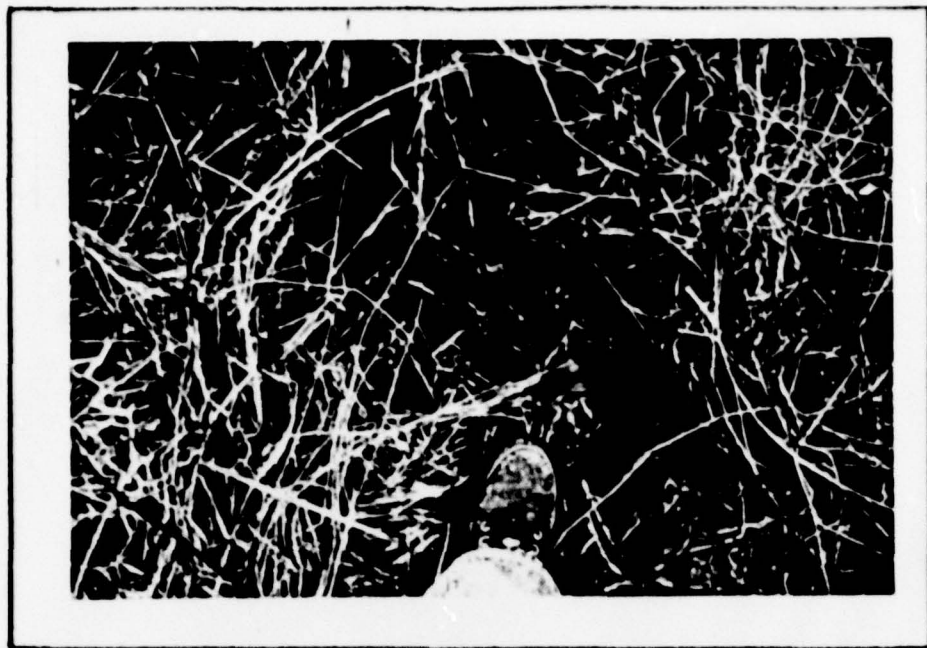
A swampy area extends from the toe of the embankment (See Plate 4 of Appendix E) for 50 to 100 feet, and along the toe from within 75 feet of the right abutment to the outlet channel. The swampy area contains approximately 12,000 square feet of saturated ground with areas of standing water 6 to 12 inches deep. In many areas, the water was discolored with brown and rusty colored deposits. The area was covered by a high, thick grass cover with clumped roots. Seepage from this area could be observed along the riprapped right bank of the outlet channel. Localized outflows of up to 15 gallons per minute (gpm) were observed, with the total outflow from the swampy area estimated at 300 to 400 gpm. Approximately 75 feet downstream of the embankment toe, an 8 inch diameter PVC pipe is constructed through the right bank of the outlet channel into the swampy area. Discharge from the pipe was estimated at 50 gpm. The origin and the purpose of the pipe could not be readily determined.

*SEEPAGE AREA DOWNSTREAM OF TOE OF DAM*

investigation should be initiated at several sections of the dam to include, but not be limited to, soil borings for determination of the composition and in situ properties of the embankment and foundation materials. Piezometers should be installed in the boreholes to evaluate pore pressure development throughout the embankment. The investigation should be supervised by a licensed professional engineer with experience in the design and construction of dams. Results of the investigation should be used to establish if the materials are satisfactory for the embankment as designed and constructed; and to detect possible fines migration.

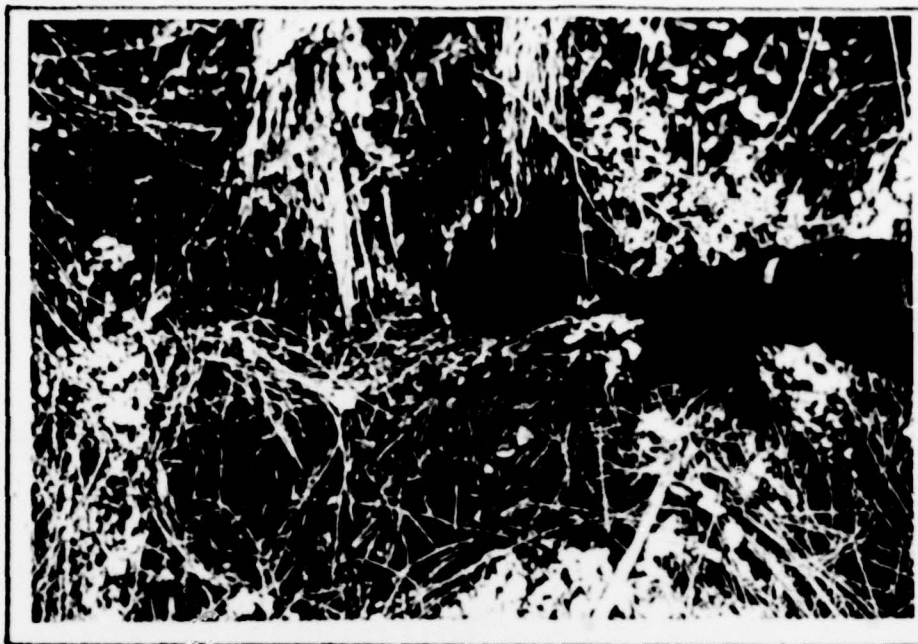
Animal burrow holes observed on both the upstream and downstream slopes could have a deleterious affect upon the seepage potential through the embankment.

*ANIMAL BURROW HOLE ON THE DOWNSTREAM  
SLOPE OF THE DAM*

6. Animal burrow holes were noted on both the upstream and downstream slopes of the dam. These holes should be filled with suitable earth materials.
7. The dam is partially overgrown with bushes and trees up to 15 feet high. The trees and bushes should be cut at the ground level.
